HACKENSACK RIVER BASIN

ORADELL RESERVOIR DAM

**PHASE I INSPECTION REPORT
NATIONAL DAM SAFETY PROGRAM**

NJ 00258

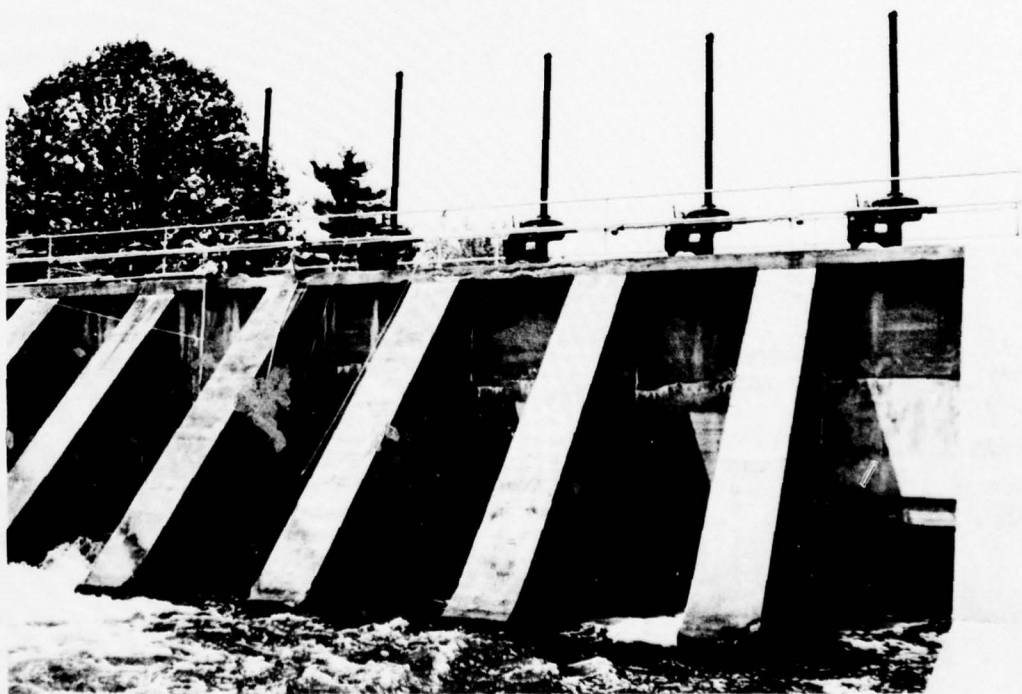
PHOTO 8

Photo 8 - View Upstream (Northwest) at Sluice Gate Section From Downstream End Training Wall Between Sluice Gate and Spillway Sections (Photo 3); Spillway at Right Edge of Photo - 12 June 1978
